Manhole Inspection Summary

Manhole # S37MM_047MH

Insp Date: **2/2/07 12:53 PM**

Location Address: **717 20TH ST**

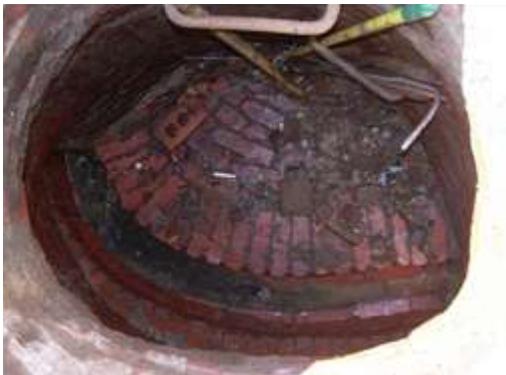
Top View

Frame leaks. Corroded steps. Evidence of surcharge - Bench debris. Channel debris.

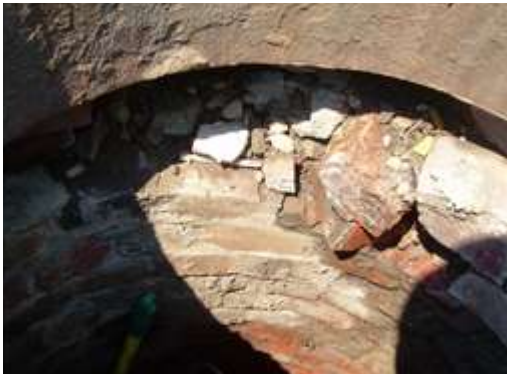
Defect

deteriorated chimney

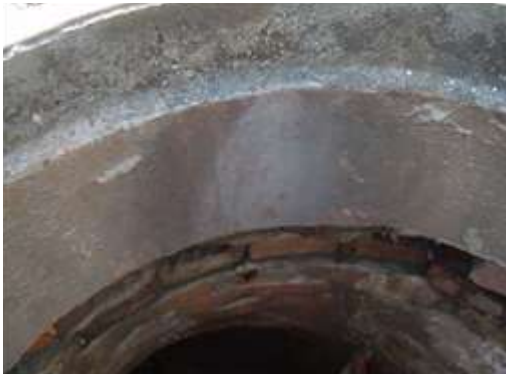
Defect

☒ **Leaks**

frame leaks

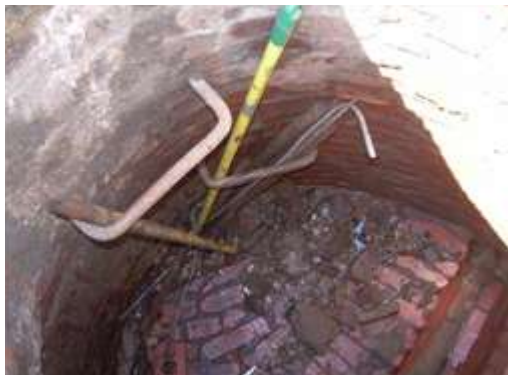
Defect

☐ Parged ☒ **Debris** (not Condition related)

bench debris

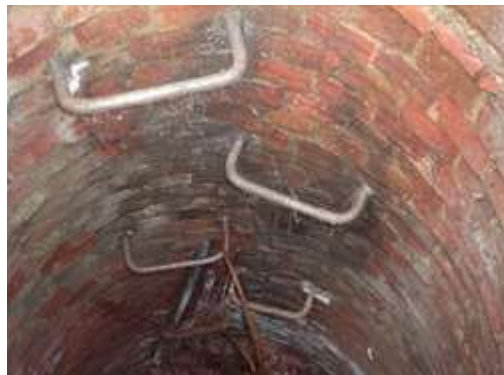
Defect

Infiltration: ☐ None ☒ **Joint** ☐ Cracks ☐ Mortar ☐ Roots ☒ **Wall**

Infiltration: ☐ None ☐ Joint ☐ Cracks ☐ Mortar ☐ Roots ☒ **Wall**

Adjustment, Corbel and Barrel infiltration.

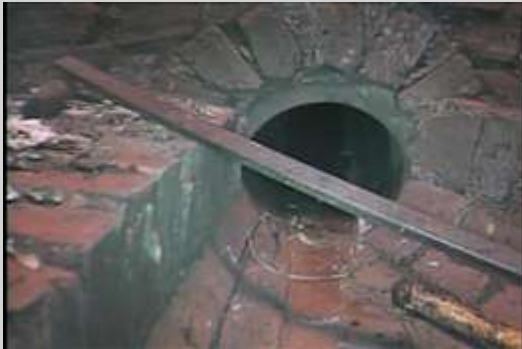
8 in. Circular Gravity Sewer Pipe Out @ 12 O'Clock

Infiltration: **None** Pipe Seal Cond: **Sound**

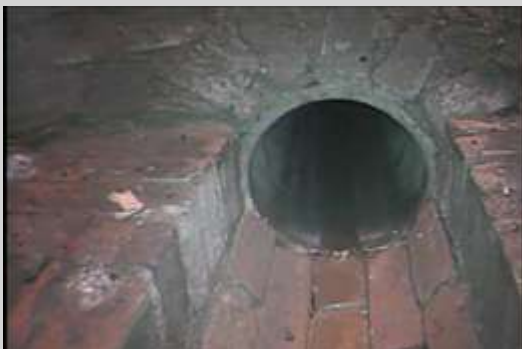
8 in. Circular Gravity Sewer Pipe In @ 9 O'Clock

Infiltration: **None** Pipe Seal Cond: **Sound**

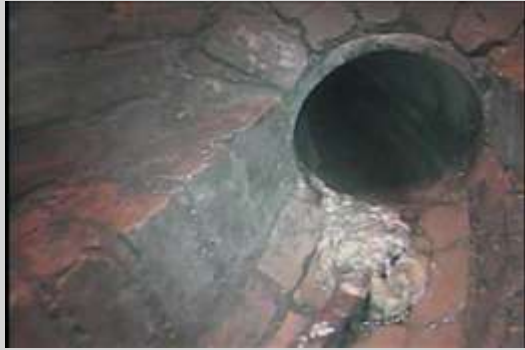
Pipe In @ 3 O'Clock

Deposits: ☐ None ☐ Mud ☐ Sludge ☒ **Debris** ☐ Grease

Silt Depth: **1** (in.)

Deposits Extent: **Light**
